DNV Container Ship Update

Information from DNV to the container ship industry No. 1 April 2008

Napoli - special edition

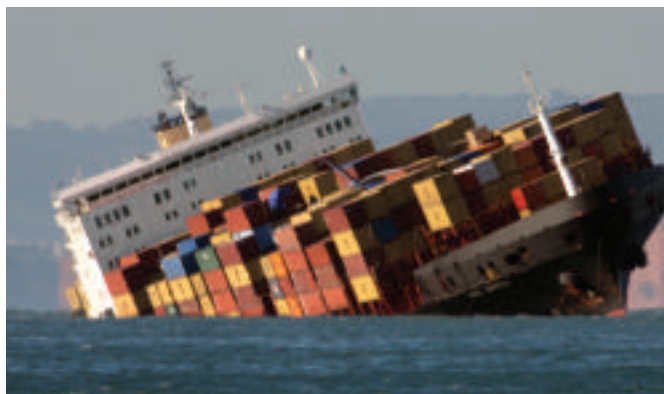
5. Grounded full of containers

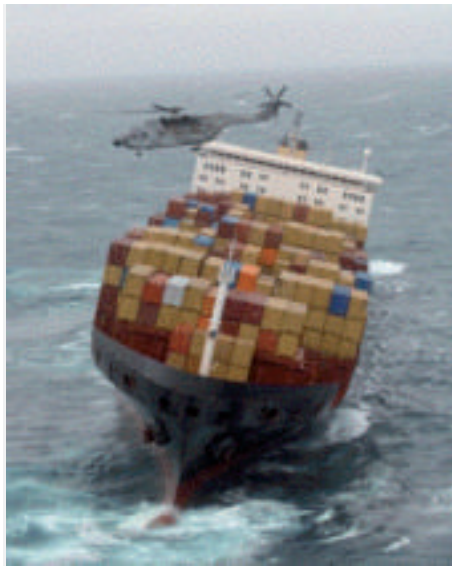
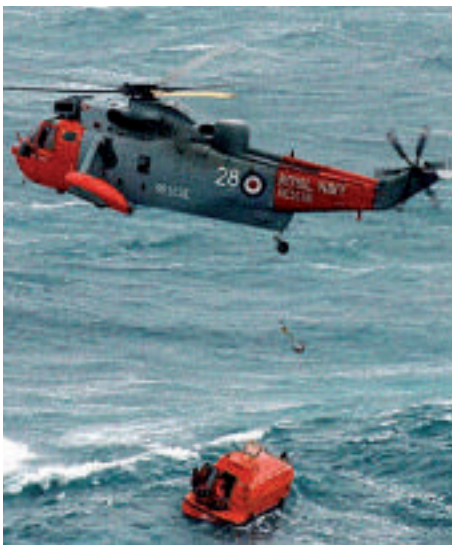
Fig.1 Rescue operation of MSC Napoli 18th of February 2007, south east of Lizard Point

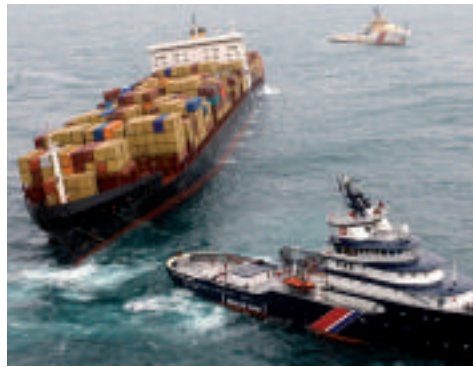
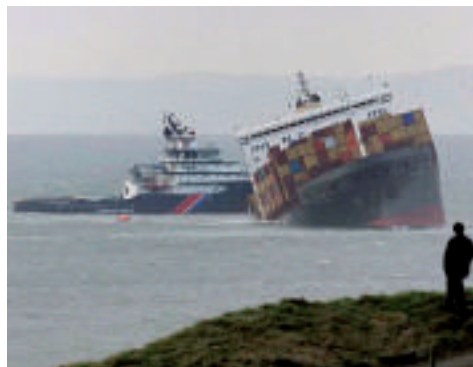
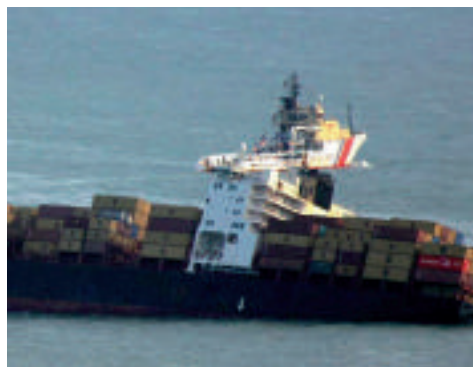
Fig.2 French and British tug vessels beaching MSC Napoli off the Dorset coast in Lyme Bay

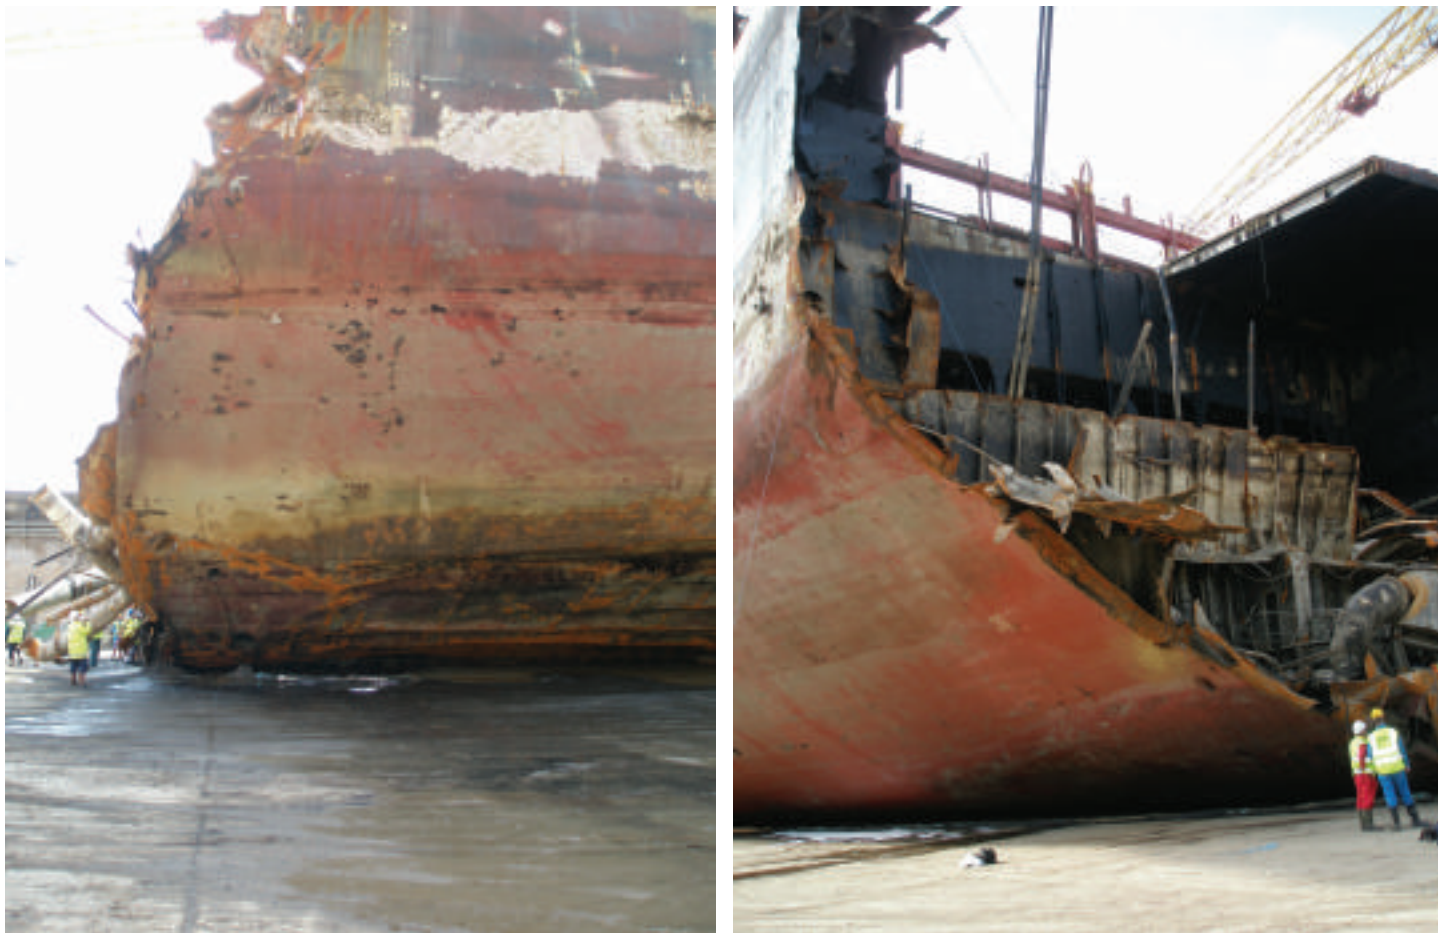
Fig.4 Forepart of MSC Napoli in dry dock in Belfast. What happened?? they wonder

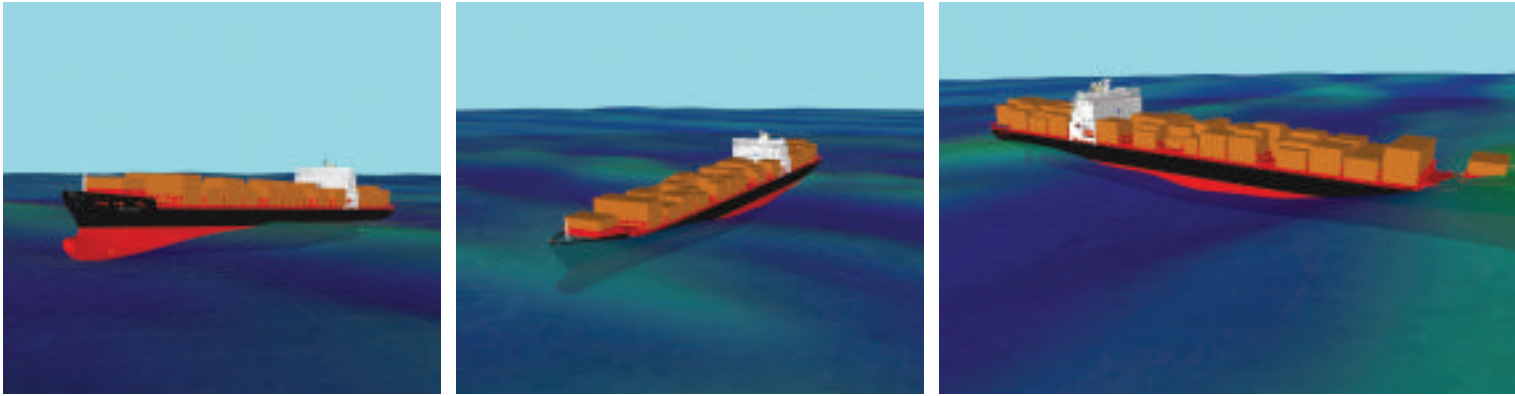
Fig. 5 MSC Napoli meeting a severe irregular wave train leading up to a severe hogging state (Hydro time serie simulation – WASIM)

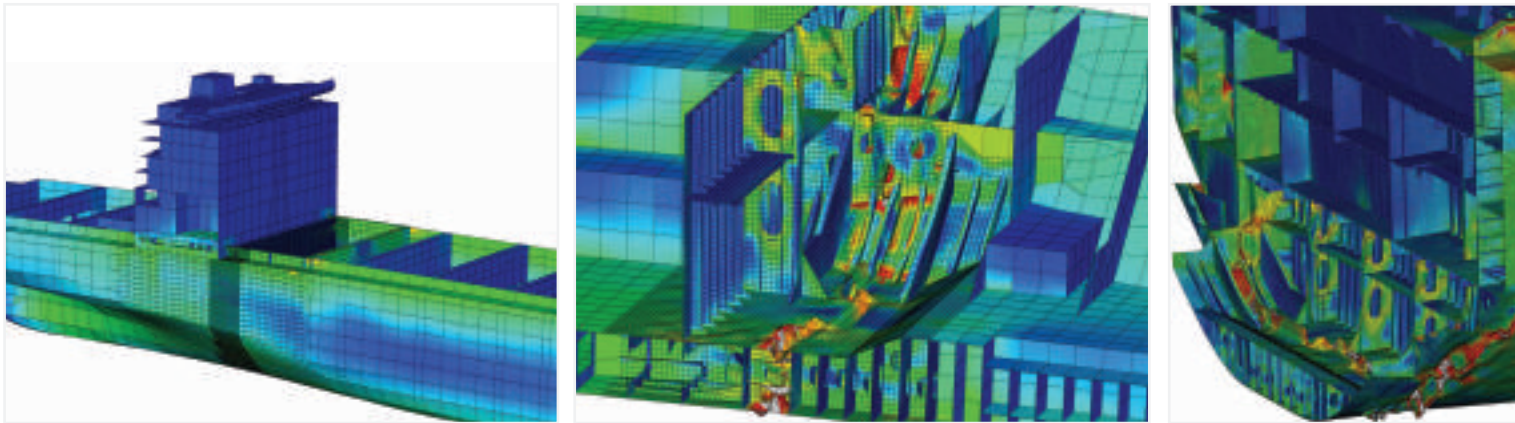
The non-linear FE model (ABAQUS) analyses were very time consuming and demanding and run for several weeks. But all the time and effort put into these analyses seemed to pay off, as a very realistic and well defined failure mechanism unfolded in the FE model. Compared to the failure mode as observed on vessel, the FE computer simulation gave a very close match.

Fig. 6 MSC Napoli; structural progressive collapse development and hull girder failure (Non-lin FE ABAQUS)

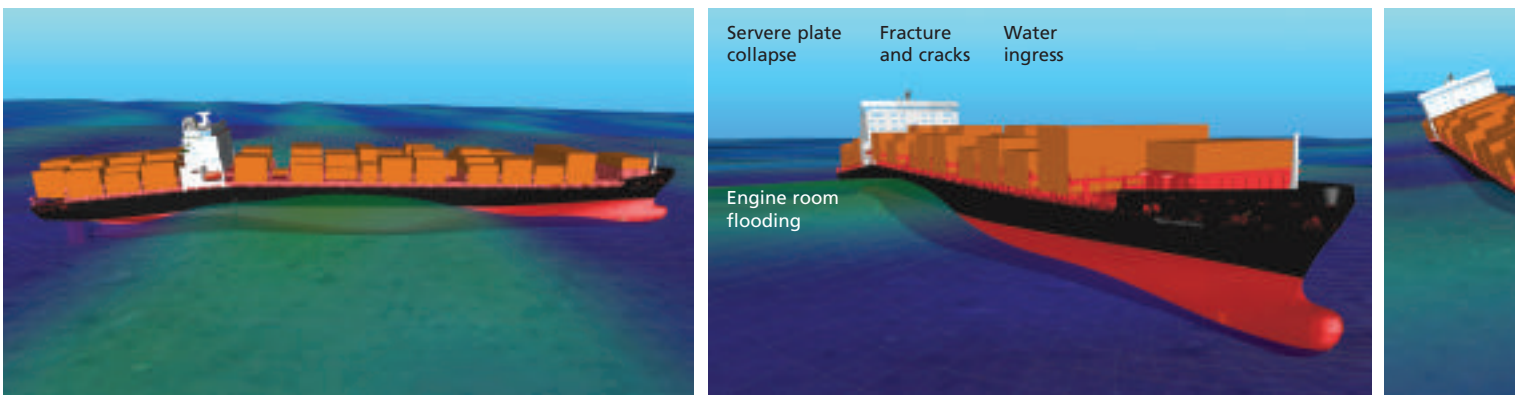
Fig. 7 MSC Napoli in a heeled and drifting state after hull girder collapse, plate cracking and engine room flooding

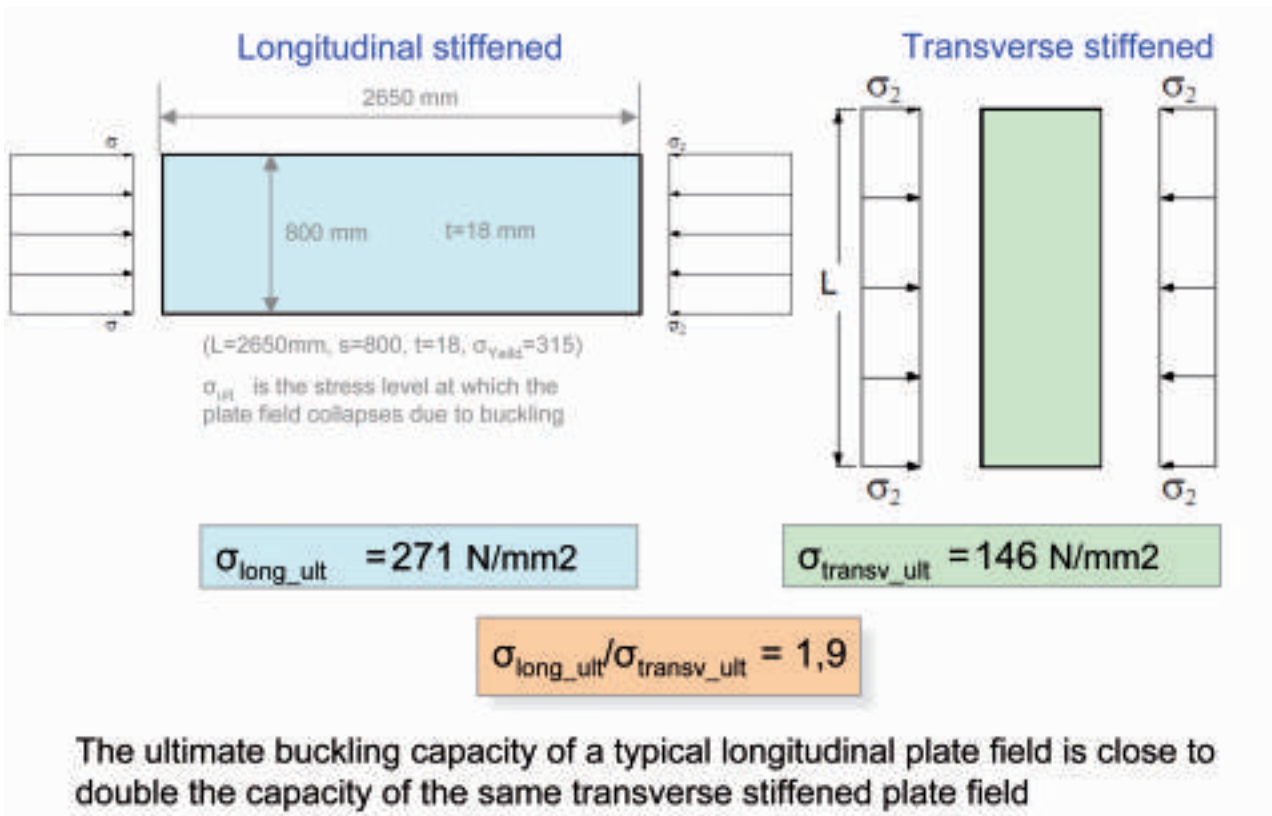
is simply that the aspect ratio of the plate field is changed by dividing the plate up into almost square panels. The effectiveness of the orientation of the stiffeners is quite significant as can be seen from the comparison below. Two plate fields of the same dimensions are subjected to the same loading, one transversely stiffened and the other longitudinally stiffened. The ratio of the critical buckling stresses

is 1.9, indicating that the longitudinal orientation is almost twice as effective as the transverse orientation.

The alternative is to increase the buckling capacity, which involves steel work. In most cases, this will be a minor job involving limited additional steel and may typically be carried out afloat, probably with a riding crew. Intercostal buckling stiffeners need to be installed in the critical area. This is illustrated in the model snapshots shown below.

The orientation and location of the intercostals are shown in the figure below, where the flat green bars are the modifications needed. The dimensions are typically some 150 x 12 mm flatbar section to be fitted in between the vertical framing. Depending on the size of
