DNV Container Ship Update

Information from DNV to the container ship industry No. 1 April 2008

Napoli - special edition

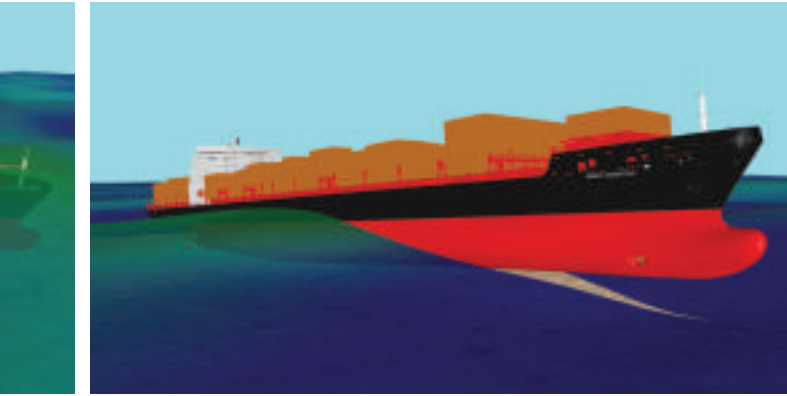
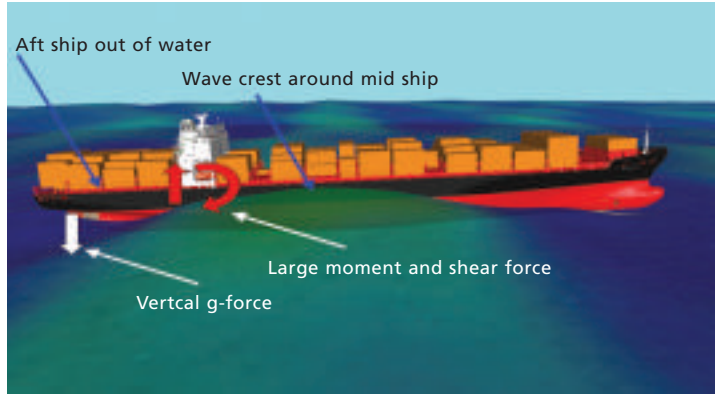
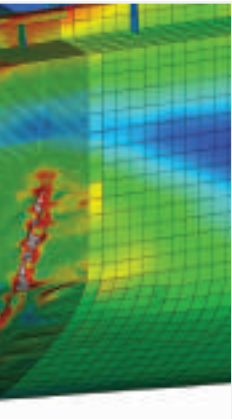
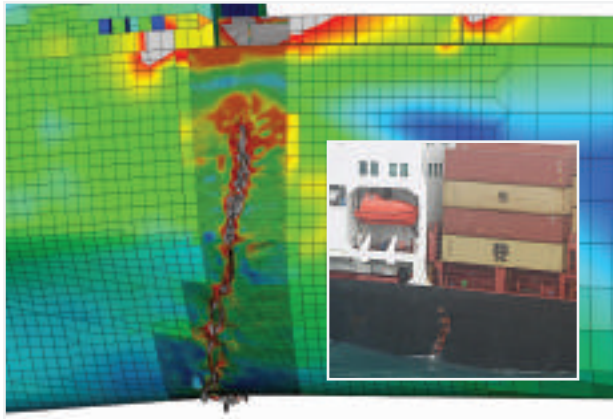
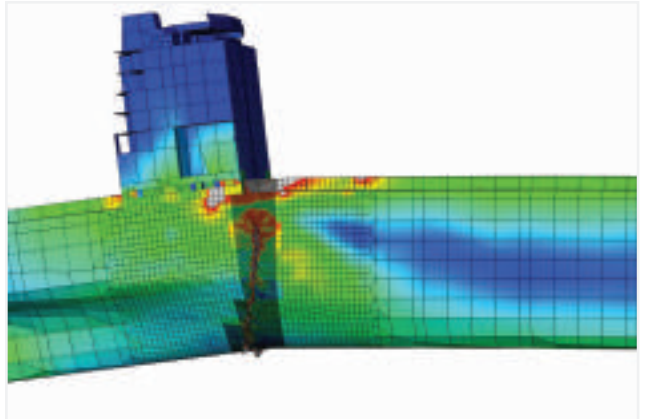
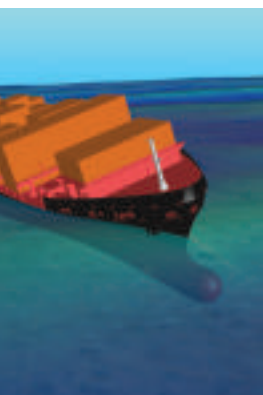
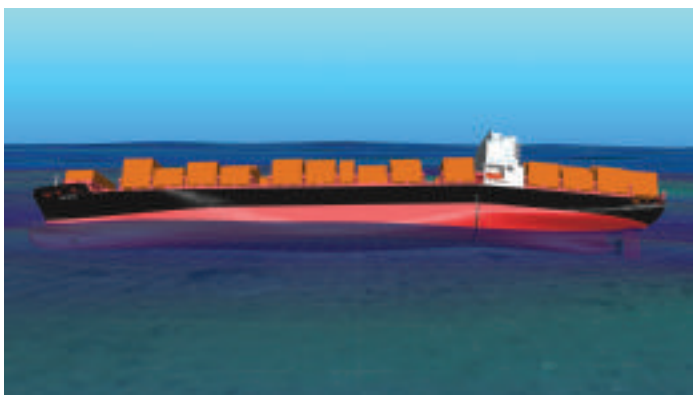
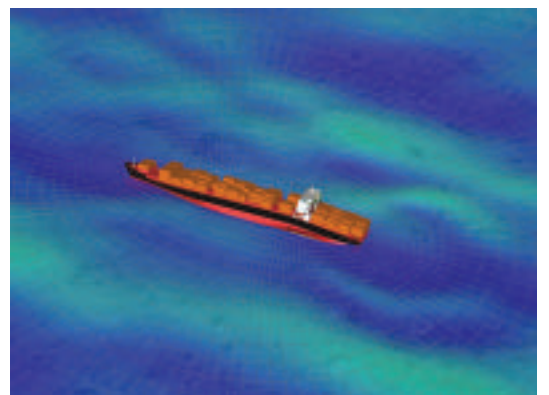
The non-linear FE model (ABAQUS) analyses were very time consuming and demanding and run for several weeks. But all the time and effort put into these analyses seemed to pay off, as a very realistic and well defined failure mechanism unfolded in the FE model. Compared to the failure mode as observed on vessel, the FE computer simulation gave a very close match.

The likely incident scenario is illustrated in a sequence of pictures in Figs.5,6,7 showing, the vessel heading up towards a severe irregular wave train as analysed using WASIM, then analysed in moment in time in the non-linear FE program ABAQUS for then in a damaged, heeled and flooded condition illustrate the vessel starts drifting without engine power and ends up rolling in beam sea.

Fig. 7 MSC Napoli in a heeled and drifting state after hull girder collapse, plate cracking and engine room flooding

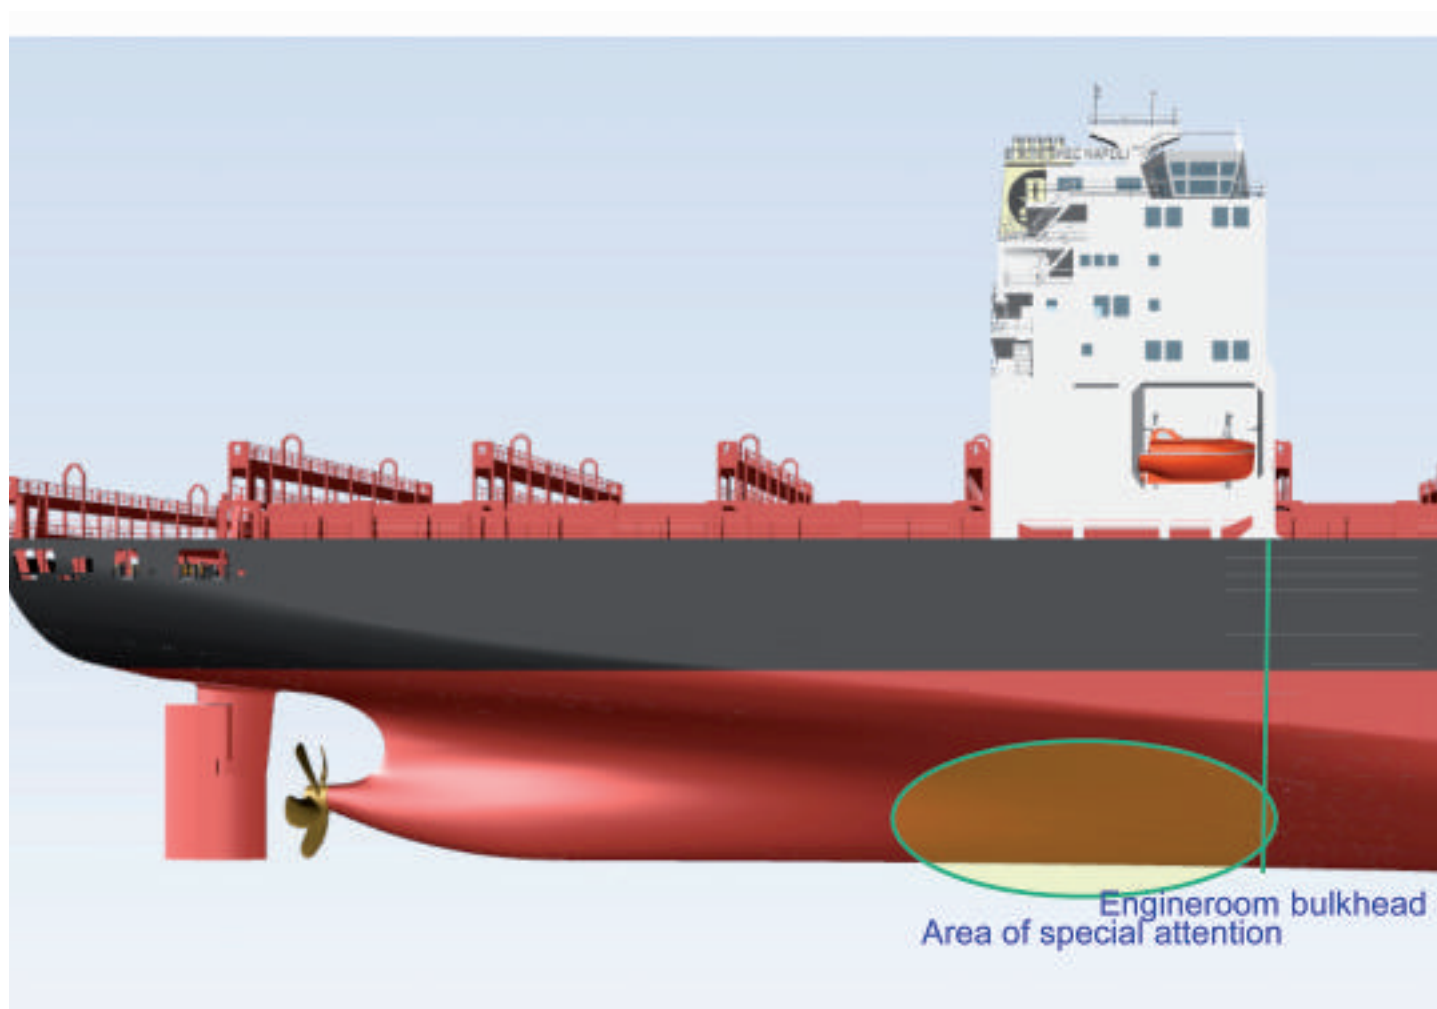
The challenge of rectifying a shortcoming in buckling capacity in the critical area can be solved in two alternate ways, either by reducing the compressive load or increasing the structure's capacity to withstand the load.

A reduction in the allowable still water bending moment will reduce the compressive load in the lower part of the hull girder cross section. This is probably the most cost-effective way provided the cargo operations allow such a measure. Not all ships may utilise their full potential with regard to container loading on the hull girder, and in such case this may be the best way out of the problem.

The alternative is to increase the buckling capacity, which involves steel work. In most cases, this will be a minor job involving limited additional steel and may typically be carried out afloat, probably with a riding crew. Intercostal buckling stiffeners need to be installed in the critical area. This is illustrated in the model snapshots shown below.

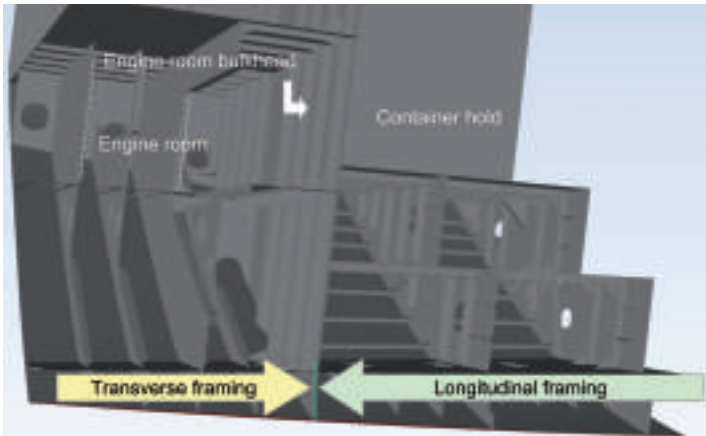
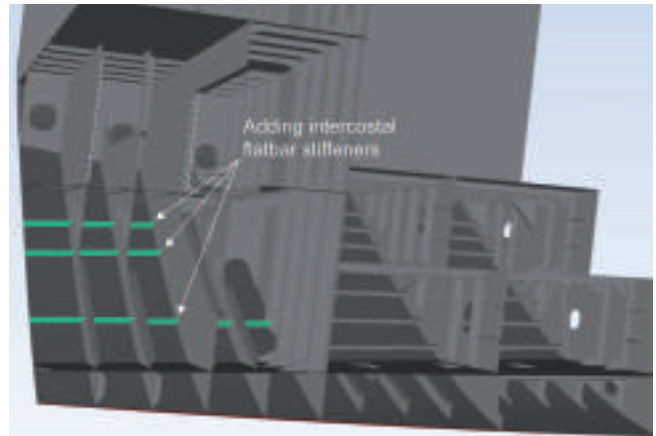
is simply that the aspect ratio of the plate field is changed by dividing the plate up into almost square panels. The effectiveness of the orientation of the stiffeners is quite significant as can be seen from the comparison below. Two plate fields of the same dimensions are subjected to the same loading, one transversely stiffened and the other longitudinally stiffened. The ratio of the critical buckling stresses

is 1.9, indicating that the longitudinal orientation is almost twice as effective as the transverse orientation.
